Case History No.: 99-6253-98
Date: Feb. 1999
Description: Rip Saw Falls - Field Modification of Existing Flume Ride
Location: Orlando, Florida
Owner: Universal Studios Florida

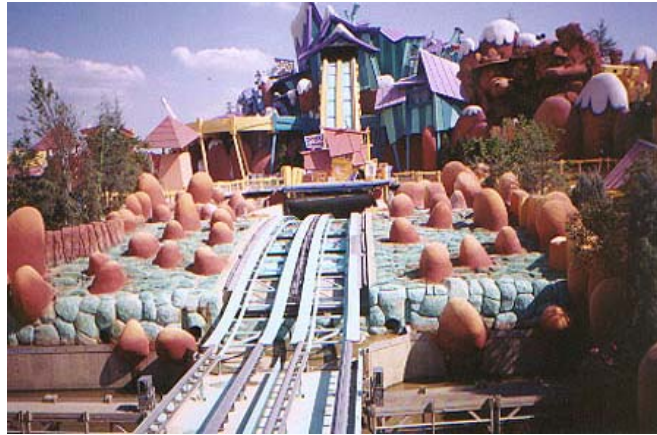
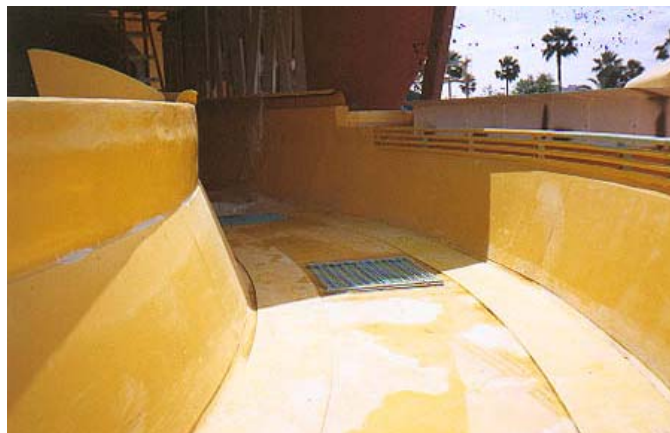
The project team asked IPS to inspect the 870 lf run of FRP flume. The European manufacturer had an extensive finite element analysis and design complete on the flume framework, and nothing done on the flume itself. Upon inspection, it was noticed that the flume deflection between spans was dangerously excessive. IPS's engineering department determined that the flume, as it stood, was inadequate. The original flume was 3/16" thick. Our design required that an additional 1" of thickness be added. We staffed the repair with 40 +/- laborers and completed the relining in three weeks time.
