Case History No.: 02-7307

Description: 36"ø FRP Pipe, Fittings and Field Labor for Alafia River Crossing Project (Directional Bore)

Owner: Tampa Bay Water Authority
Hillsborough County, FL

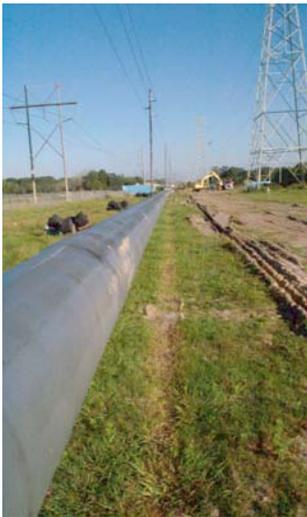
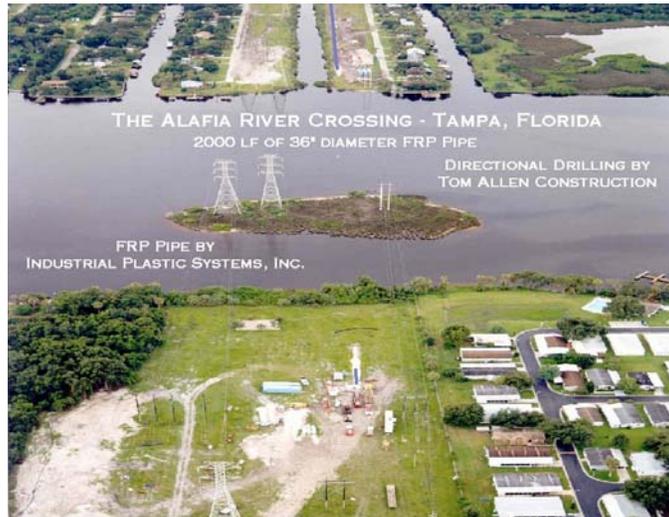
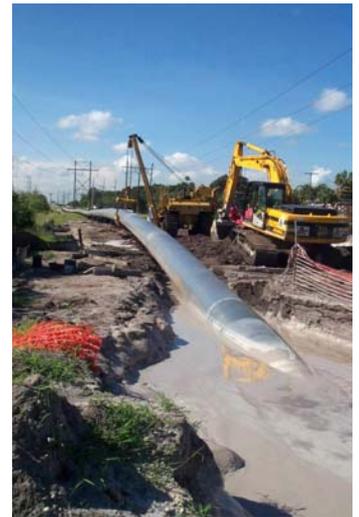
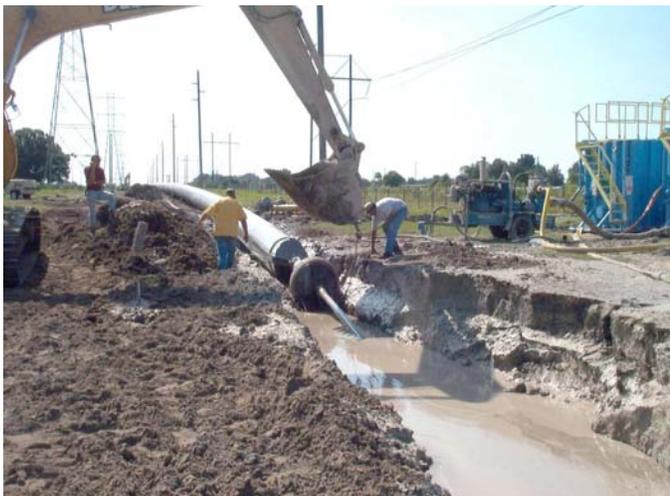
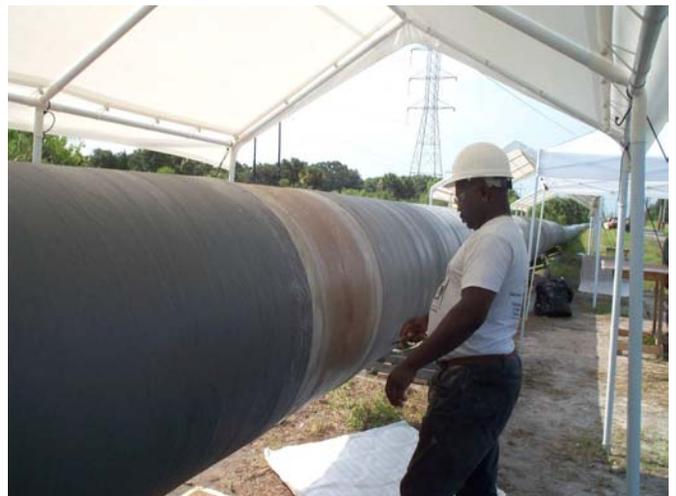
The crossing of the Alafia River required 2040 LF of pipe installed 50 feet below the river. The installation procedure included complete assembly of the pipe on the riverbank and positioning the pipe on rollers to aid in making the pull. Because of concern for the effect of abrasion on the exterior of the FRP pipe when pulled through the borehole, IPS had to satisfy the engineers that we could solve this problem. When steel pipe is used, a special coating is applied. We compared the test results of that special coating with our own abrasion resistant product and duplicated their test by installing four 10" square FRP abrasion coated panels in the corners of a specially fabricated pallet. We placed a 3500-pound load on the pallet and pulled it down a concrete pad. Under these conditions the coating used on the steel pipe survived for a 50' pull, while our own coating was pulled for 200' with only a partial wear experienced.

The actual installation involved boring a hole under the river, hooking to a pulling head welded to our pipe, pumping the drilling mud into the bore and pulling the pipe under the river. The pull was successful but not uneventful. The section of pipe just past the steel pulling head cracked and partially opened up during the pull. After completion of this repair, the pipe was pressure tested, and the pull finished without incident.

For these projects IPS developed an external weld that allowed us to have a perfectly smooth O.D. With this type of joint the pipe has to be laid out in a straight line a length equal to the pull length. In many crossings the luxury of having this amount of space available adjacent to the pull may not be possible. In the probability of space limitations, we have developed a locking bell x spigot O-Ring sealed joint that can be assembled in the field as the pull is taking place.

On both pulls, we experienced cracks in the pipe just past the pulling head. Both section were repairable. The difficulty with the second pull (Bull Frog Creek) was compounded when a dewatering pig exploded gouging the inside of the pipe. The damage was repaired and the line was accepted for use.
